**Tree Inventory and Preservation Plan Report
5500 Dundas Street West
Toronto, Ontario**

11 December 2025

KUNTZ FORESTRY CONSULTING INC Project P4815

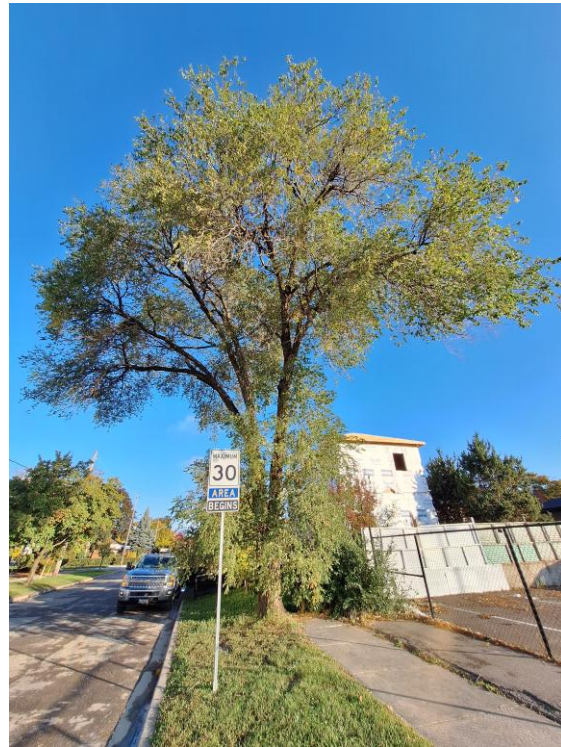
Image 2. Tree 2

The removal of Trees 2, 7, and 8 (3 trees) is required to accommodate the proposed development. Trees 2 and 7 have direct conflicts with the proposed driveway. The removal of Tree 8 is required to accommodate a new swale drain and re-grading. Refer to Figure 1 for the locations of the required tree removals.

Trees 2 and 7 are located within the road right-of-way and protected by the City of Toronto Public Tree By-law (category 5 trees). Tree 8 is greater than 30cm DBH located on the subject property and protected by the City of Toronto Private Tree By-law (category 1 tree). A permit will be required prior to their removal.

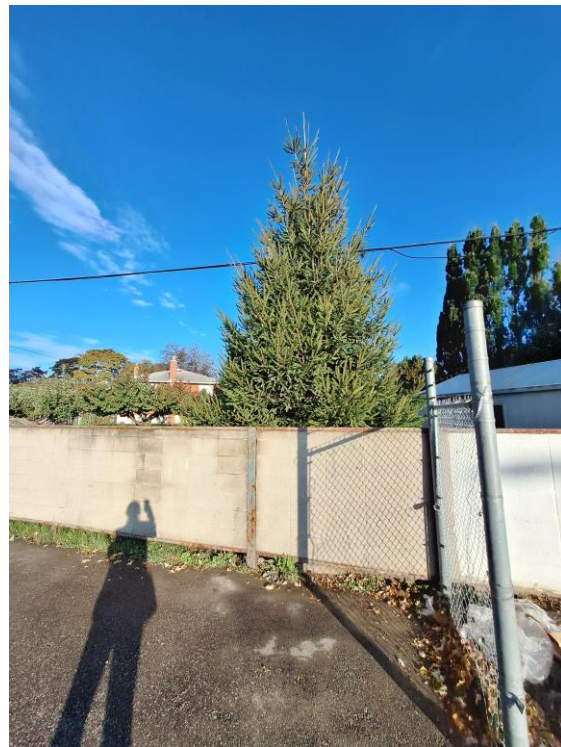
Image 8. Tree F

Encroachment into the minimum Tree Protection Zone (mTPZ) of Trees E-H, J-M, and P is required to accommodate the proposed development. The existing asphalt driveway along the property line will be demolished and a new driveway will be installed at 2.2m from the property line (away from the trees). The area between the new driveway and the property line will be soft-scaped. Given that no root pruning will be required, long-term adverse impacts are not anticipated to the trees. The following mitigation measures must be implemented to ensure the trees respond well to the impacts of the proposed development.

- The existing retaining wall along the property line will suffice as tree preservation fencing.
- The existing asphalt driveway within the mTPZ of these trees must be removed carefully with small equipment.
- The existing granular base within the mTPZ of the trees should be removed by hand tools only.
- Then the area can be amended using high-quality topsoil.

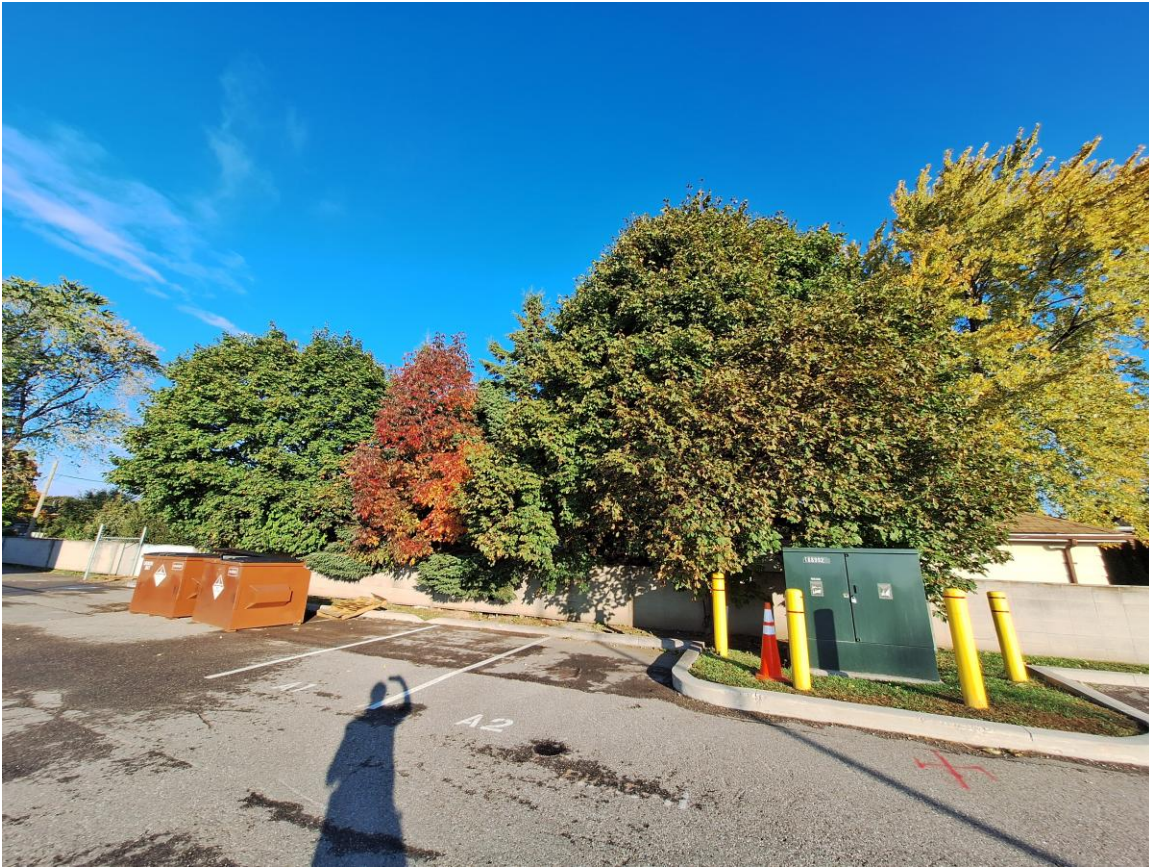
Image 9. Trees 8, A-E (from right)

Trees E, H, and O are greater than 30cm DBH located on the adjacent properties (category 2 trees) and protected by the City of Toronto Private Tree By-law. A permit will be required prior to their injury.
