**Tree Inventory and Preservation Plan Report
5500 Dundas Street West
Toronto, Ontario**

11 December 2025

KUNTZ FORESTRY CONSULTING INC Project P4815

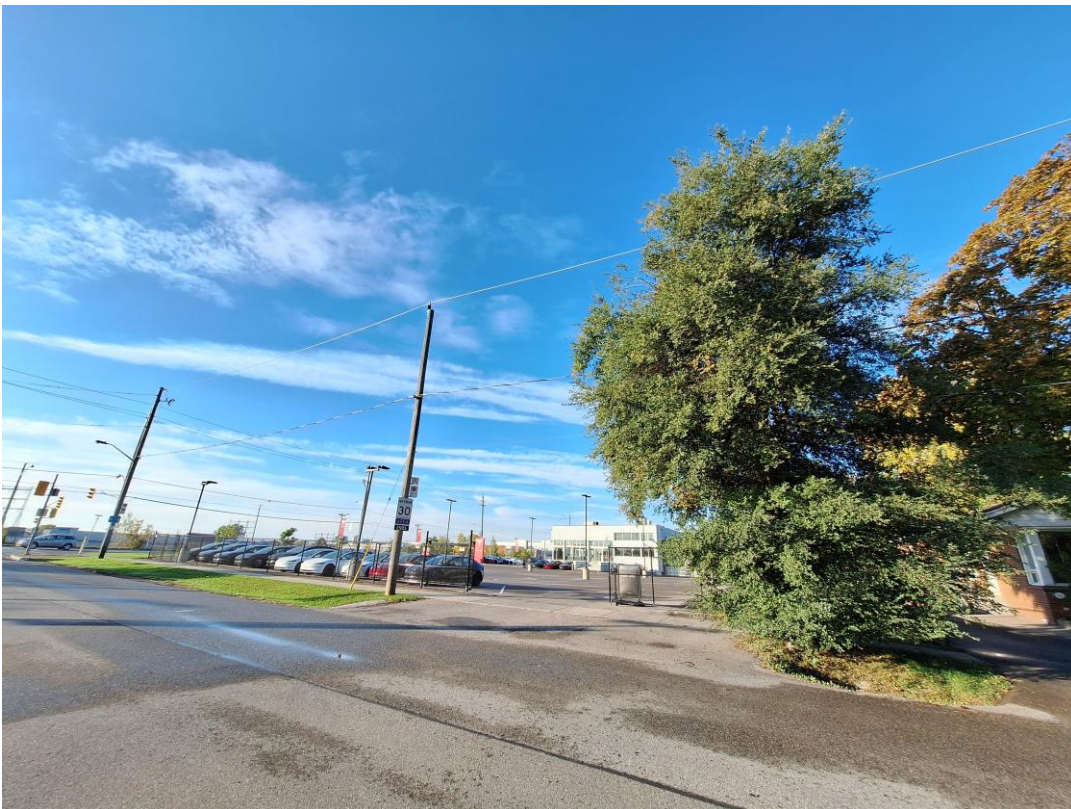
The removal of Trees 2, 7, and 8 (3 trees) is required to accommodate the proposed development. Trees 2 and 7 have direct conflicts with the proposed driveway. The removal of Tree 8 is required to accommodate a new swale drain and re-grading. Refer to Figure 1 for the locations of the required tree removals.

Image 19. View from northeast corner and Tree 7 on the right
